NILE RIVER BANK EROSION AND PROTECTION

Nile Basin Capacity Building Network

2010

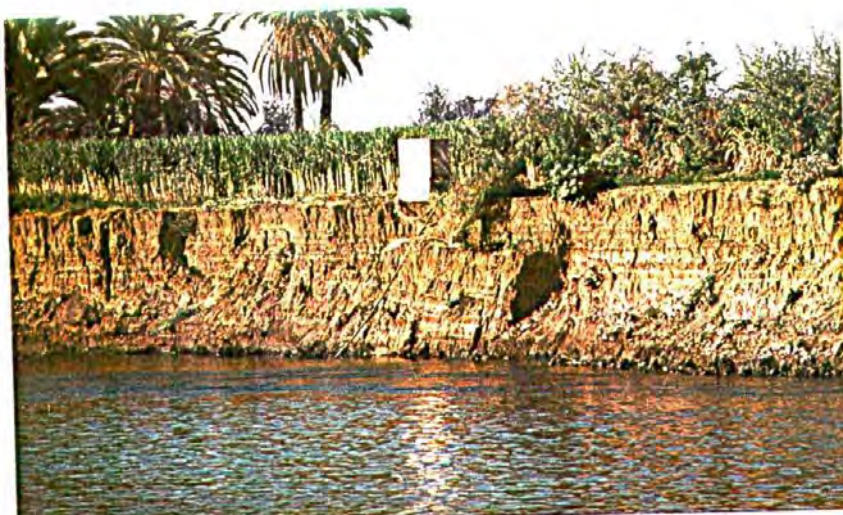
Figure 2- 1:Typical Bank Erosion at Luxor

Recorded Previous works in relation to the Nile River generally could be observed in two reaches based on the scale of bank erosion. The first reach is the part of the Main Nile downstream the High Aswan Dam (HAD) while the second reach is that part between Khartoum and third cataract. After the construction of HAD the downstream river reaches responded in a different manner. The river velocity influences Nile Bank Erosion in Egypt. As the river changes its flow pattern, the location and the riverbank erosion extent also change. **Figure 2.1**, shows typical bank erosion at Luxor.

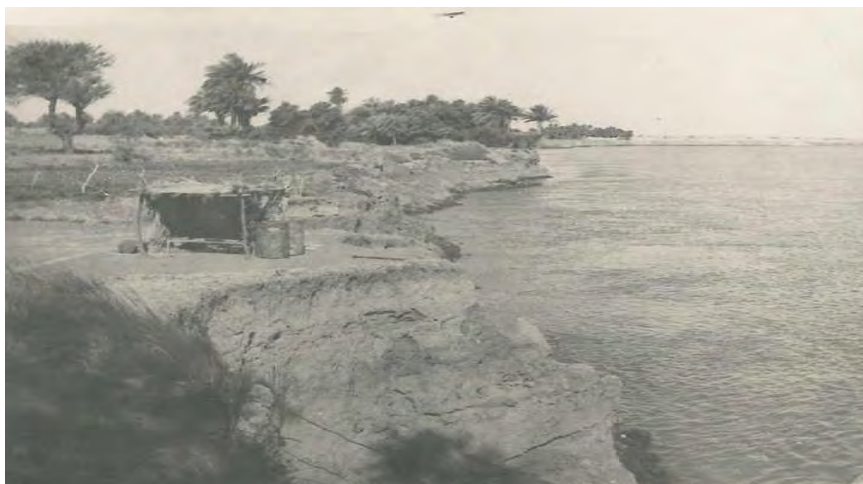
Figure 2- 2: Very Severe Bank Erosion Dongla – Merowi Third Reach

With respect to bank erosion, the Nile reach in Sudan can be divided into four reaches. The first one is between Khartoum and the fifth cataract. Second reach is from the fifth to the fourth cataract. Third reach is between the third cataract and fourth cataract. The last reach is from the fourth cataract to HAD Lake. The first and the third cataracts are reported to have noticeable bank erosion. The large and rapid drop of the water level and the high velocities are the main reasons for bank erosion of the Nile in Sudan. Figure 2.2 shows typical severe erosion in the third reach.

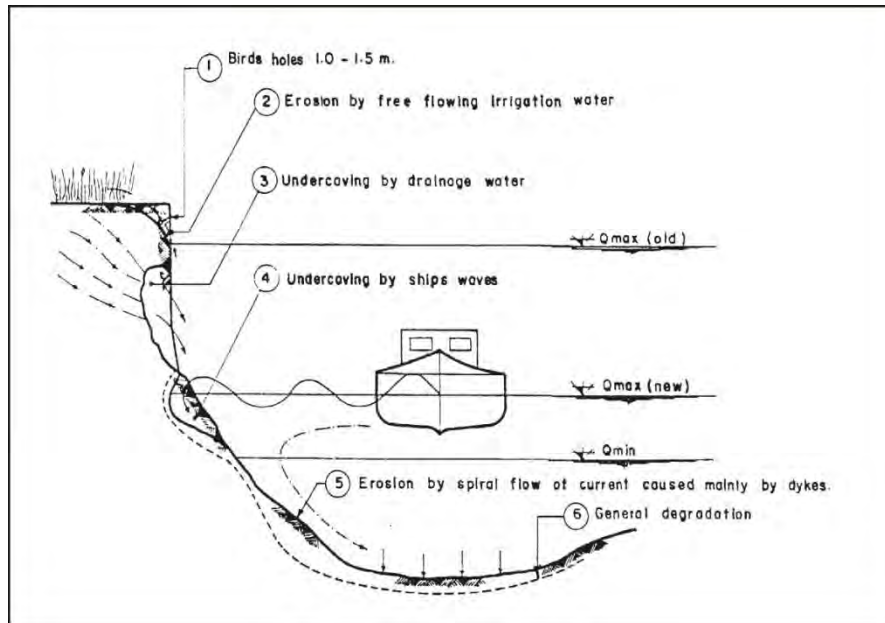
Figure 2-3: Drainage Water Caused Under Caving During HAD Construction

- ❖ **Seepage**. Seepage flow through the bank soil usually happens as a result of increasing pore water pressure within the soil. Drainage water causes under caving of the banks as shown in Figure 2.3.

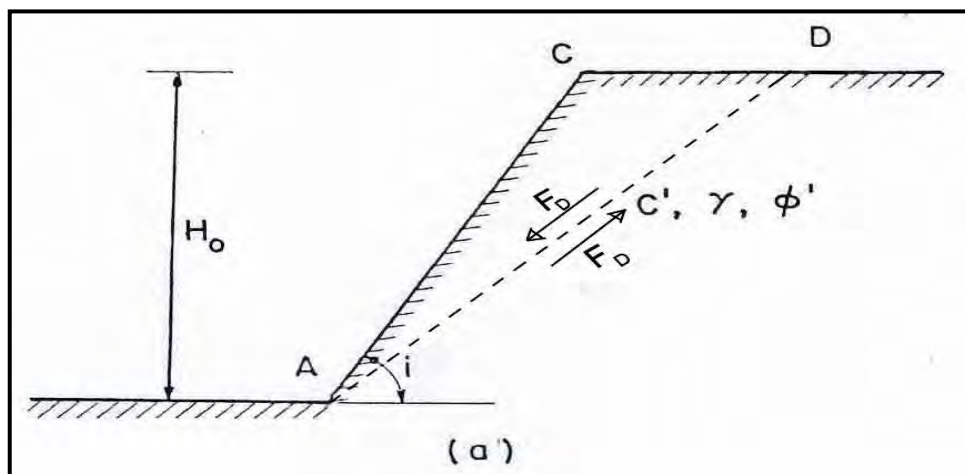
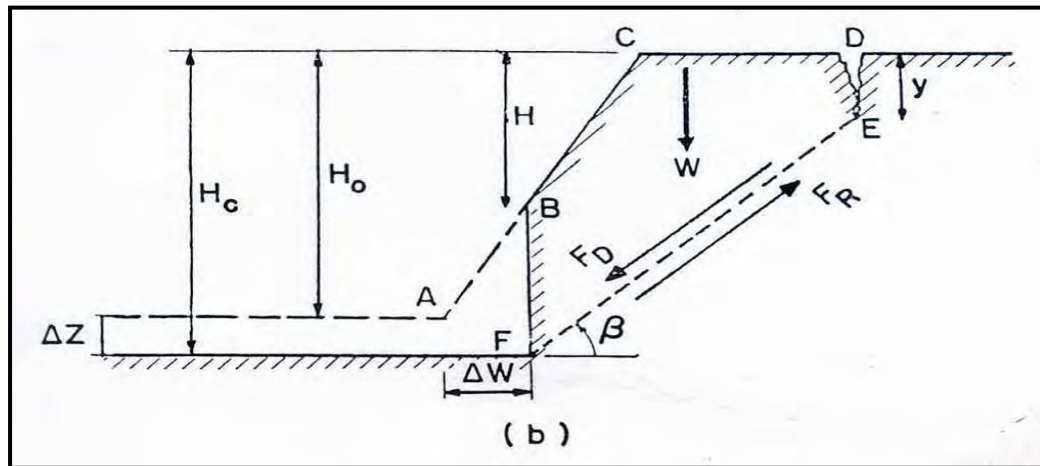
Figure 2- -4 a): River right bank at failure **b)** Parallel bank retreat

- ❖ **Bank heightening.** Bed lowering due to local scour or bed degradation results in increasing the bank height hence reducing the stability of the bank slope (reduced factor of safety).
- ❖ **Ship waves.** Ship waves erode banks at the water level as illustrated in Figure 2.3.
- ❖ **Steep bank slope.** Bank steepness reduces the stability of the banks. This is usually observed at the bank of outer bends where the induced flow shear acts over the entire bank slope giving steep slope, with reduced factor of safety, as shown in Figure 2.4,

As given in Figure 2.2a,,for intensive deep tension cracks the bank geometry of Figure 2.2b should be used in the analysis which is known as parallel bank retreat. Mass wasting, sloughing and head cutting on vegetated or barren banks are some of the mechanisms of bank failure. Bank erosion process is either mass failure of the bank (block failure) or direct erosion of the bank material. Cohesive soil shrinkage is sole factor responsible for tension cracks development. This process is more pronounced at the outer bank in river bends.

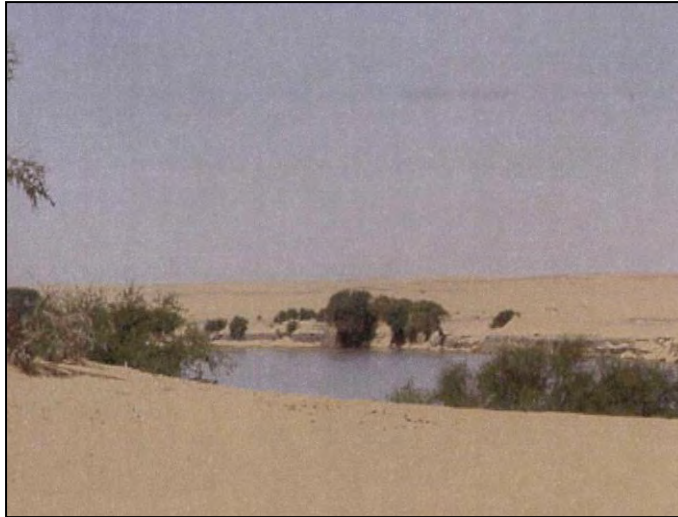
Figure 3- 3: Banks of the Nile in hyper arid zone covered by sand

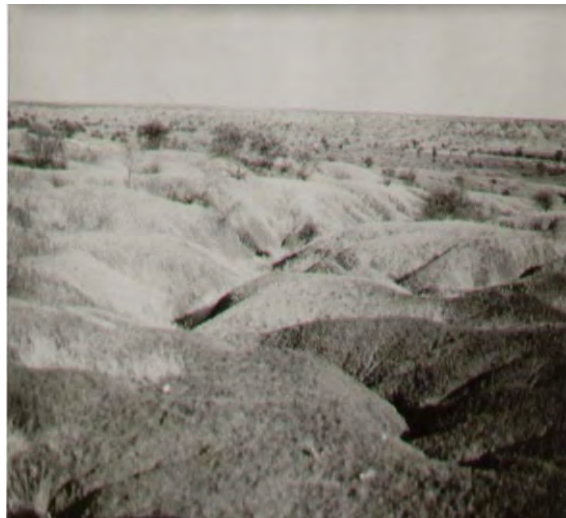
Figure 3-4 :Gully Erosion Along Atbara River farming Miscellanenus land types (Kerib land) in Semi arid zone.

mirror stereoscope. Visual interpretation of Landsat images (MSS) (TM) (ETM) were interpreted to identify the belts of barachan sand dunes along the Nile, Figure 3.5 as well different types of water erosion (gully) along Atbara river.

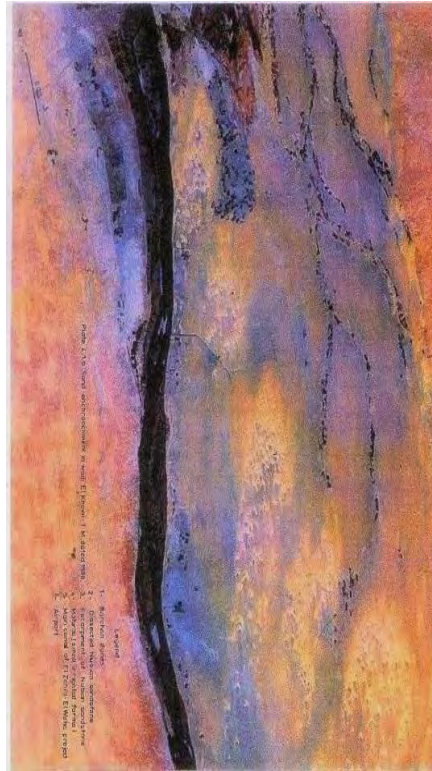
Figure 3- 5: Landsat (TM) Showing Five Colonies of Barchan Dunes of the Eastern Bank of the Nile River

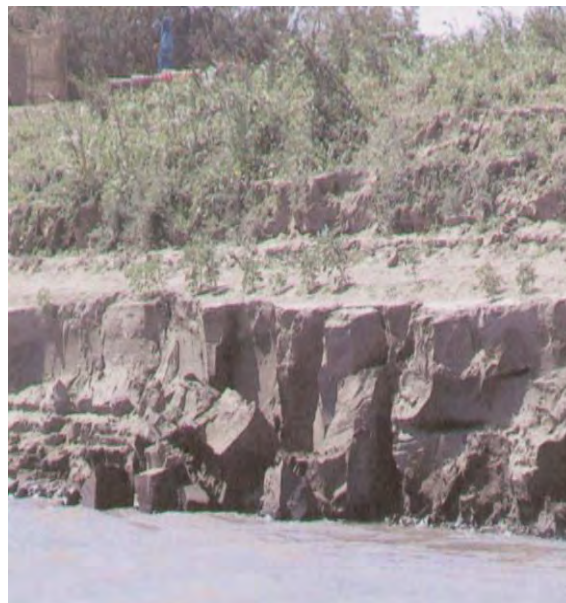
Figure 3-6 : Bank erosion – failure as a beam type in Northern State (Karima – Dongla Reach)

The digital camera was used to document the different types of bank erosion along the Nile (Figure 3.6 and Figure 3.7). The recognition of bank erosion types will help in suggesting the protection measures.

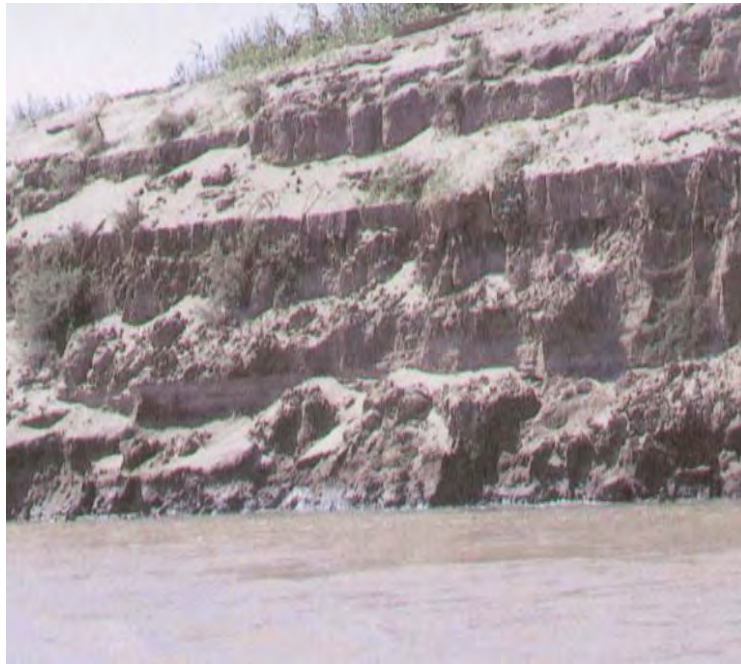
Figure 3- 7: Bank erosion – Sliding failure type in Northern State (Karima – Dongla Reach)

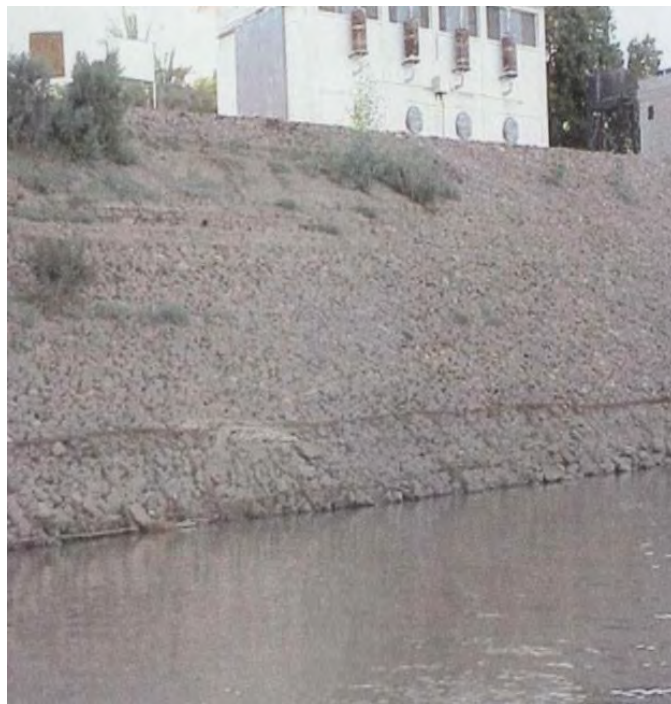
Figure 3- 8: Protection of pumping station at El-Gaba –Northern State by rock and cement

It was observed that the Nile banks consist of cohesive layers of varying thickness resting on sandy bed. The main protection methods are rock riprap Figure 3.8 and stone pitching (revetment) are commonly used in Northern Sudan.

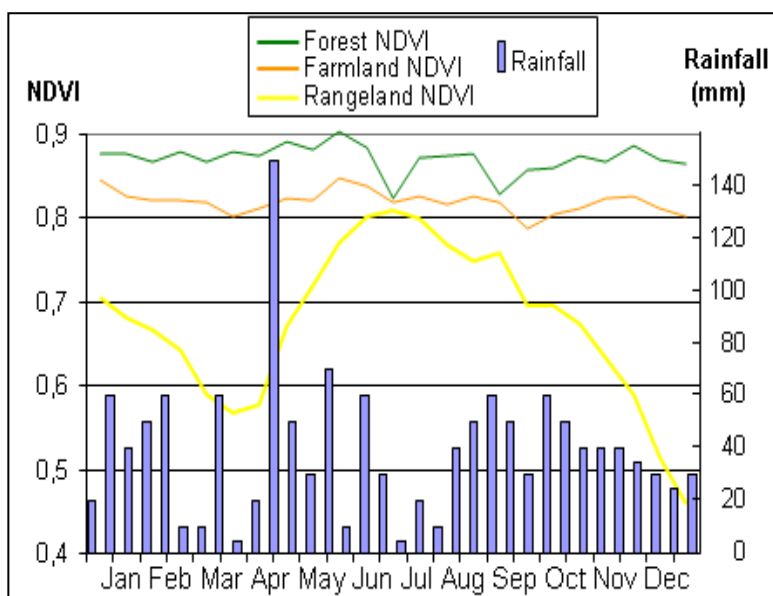
Figure 4-3: NDVI multi-temporal behavior of rangeland, farmland and forest in 2007 compared with rainfall

In the following paragraphs the dynamic behaviors of the some of the considered cover types are described in terms of NDVI variations throughout the year 2007. The multi-temporal NDVI behaviour of the sampled rangeland pixels in 2007 is represented in Figure 4.3 and compared with the contemporary rainfall data in Nyanza Region (source: FAO/GIEWS, 2009). The rangeland NDVIs show the typical natural trend of the spontaneous vegetation, as the curve follows the rainfall trend after a short delay. Whereas the farmland curve is rather more constant in the time as effect of the irrigation and/or farming practices, which tend to maintain a vegetated land cover also in the dry season. However, the farmland curve may be the result of the average behavior of many crops that can be differently scheduled along the year. The forest NDVI values, as expected, are also relatively constant throughout the year and always higher than the other cover types, Figure 4.3.

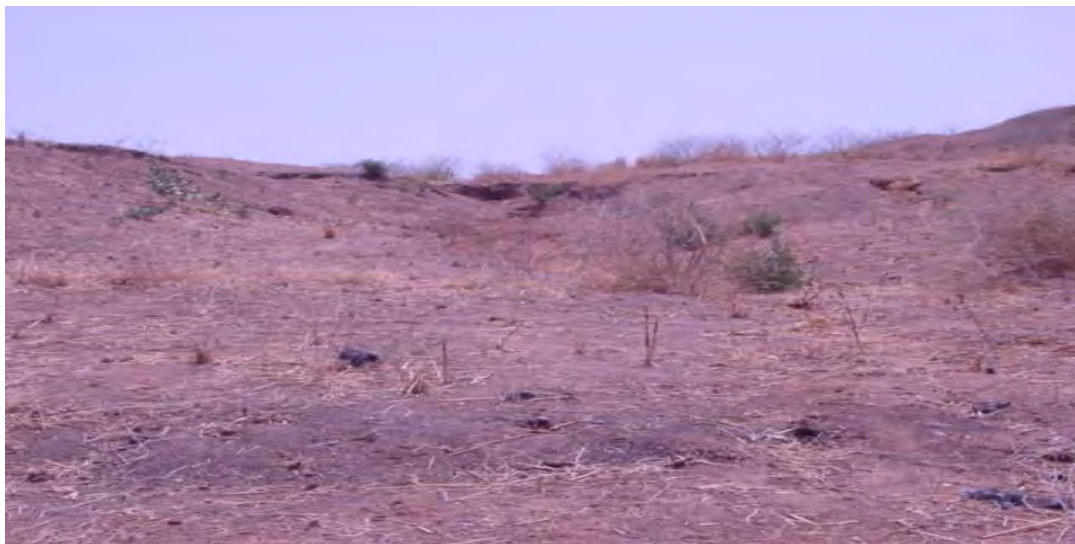
Figure 4- 10: Cultivated gully floors in the Blue Nile area (UmRamad)

In areas such as Al showak where some conservation practices by restocking of Kerib land using several tree species was undertaken by the Forestry Department. The bottoms of the gully floors are sometimes cultivated by millet, sorghum, okra and maize crop, making use of higher water content, which provides better conditions for both trees and crop growth such as at Umrabya in AlShowak and Abu Ramad in Damazin areas as shown in Figure 4.10.

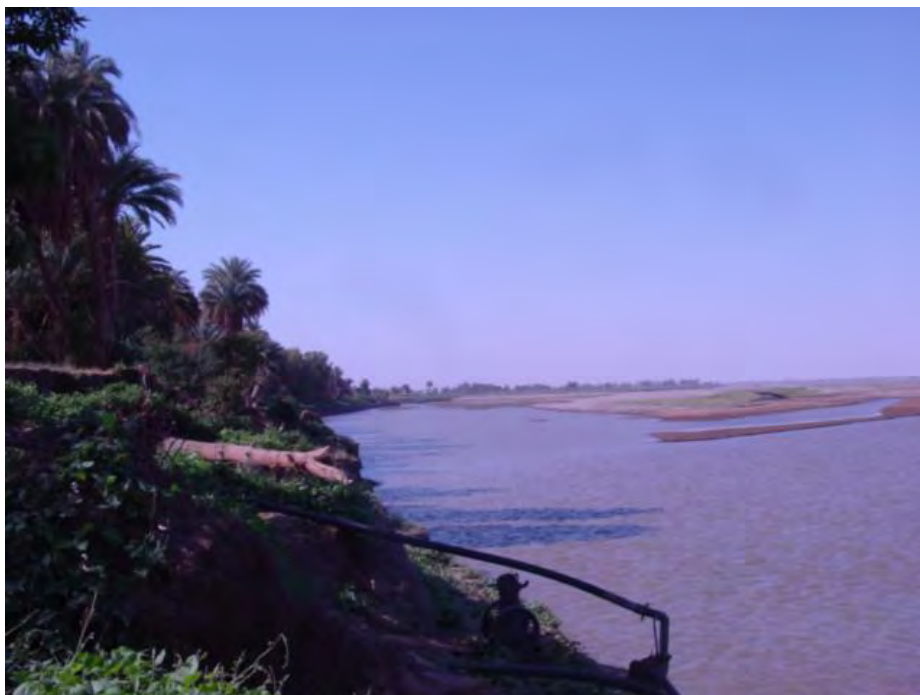
Figure 4- 12: River bank erosion along the Main Nile River (Barber area)

The real threats and adverse impact for the bank erosion were experienced on physical damage to buildings and other properties in the vicinity of its course. Typical example was the Forestry Department Rest House at AlSuki Figure 4.13. The rest house which used to be about 120 m away from the shore is now nearly to collapse. Similarly pumping houses of many irrigation schemes and private buildings were reported collapsed under the influence of the bank erosion.

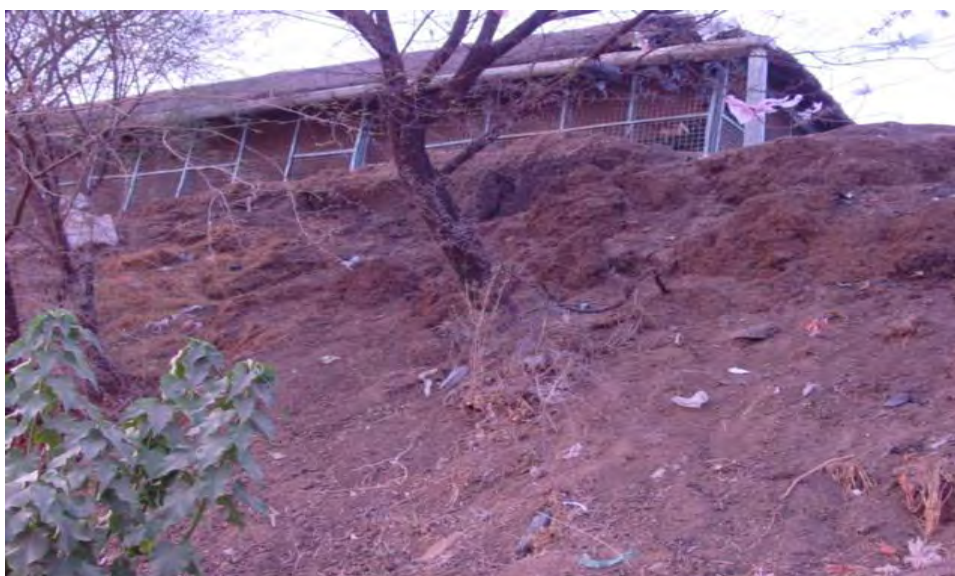
Figure 4- 13: River bank erosion at Forestry Department Rest House at AlSuki

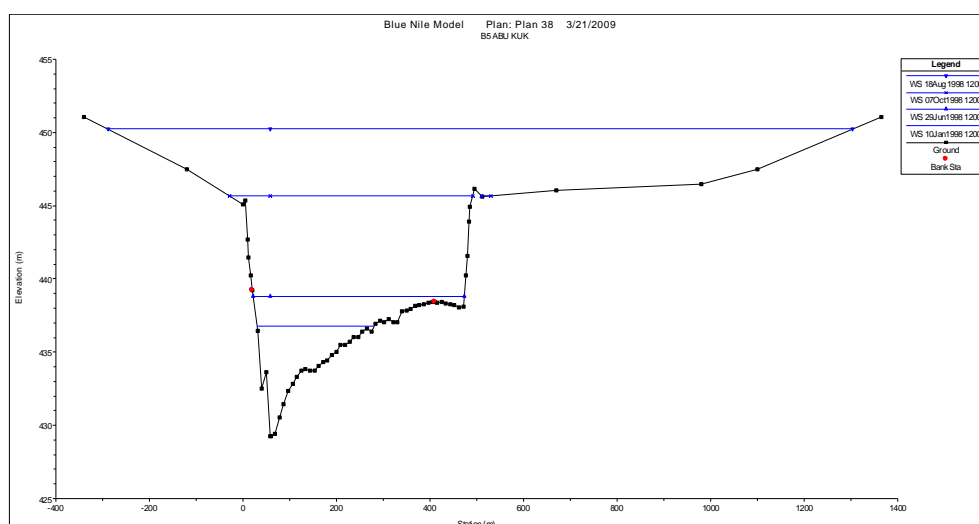
Figure 5-3a: Cross-Section with water surface elevations at different times in 1998

The Water surface elevation at peak time and during rising and falling limbs are superimposed on the channel cross-section as shown in Figure 5.3a. The velocity and shear stress hydrographs are shown in Figure 5.3b and 5.3c. The cumulative mass bed change with time for the cross-section is given in Figure 5.3d.

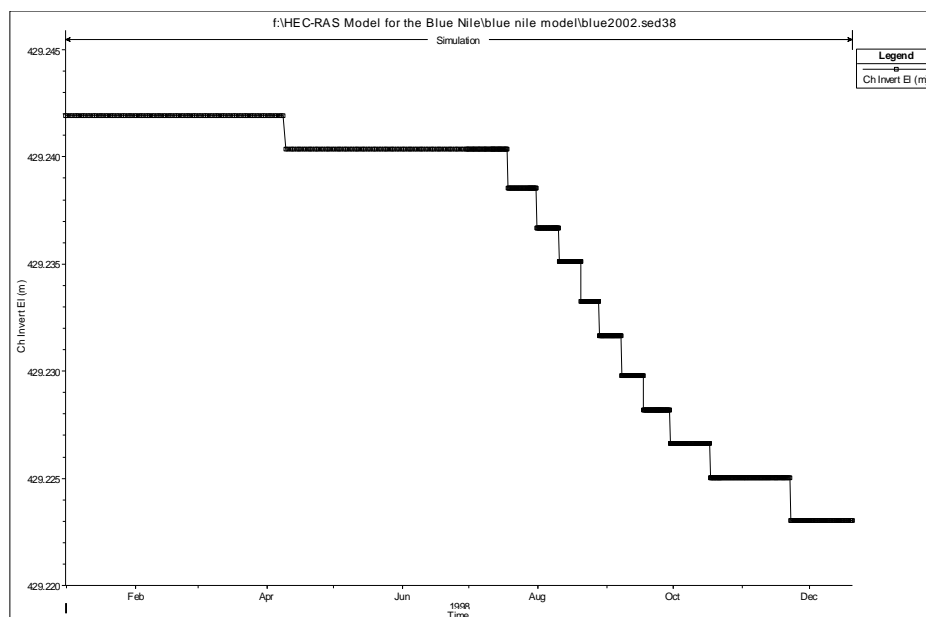
Figure 5-3b: Changes in channel invert with time

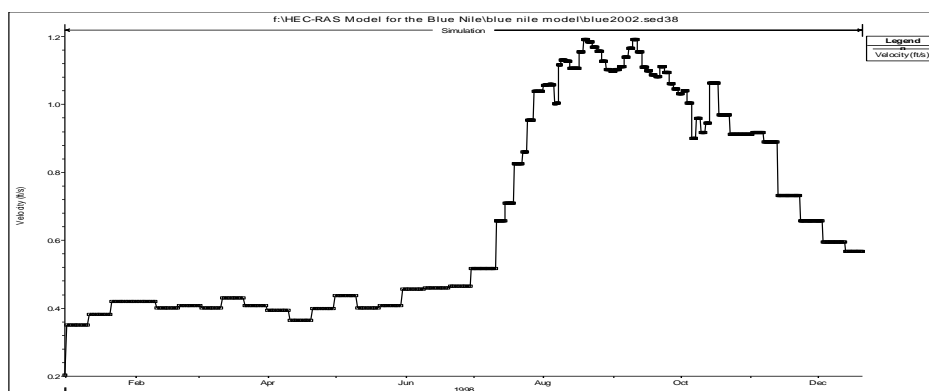
Figure 5-3c: Velocity variation with time

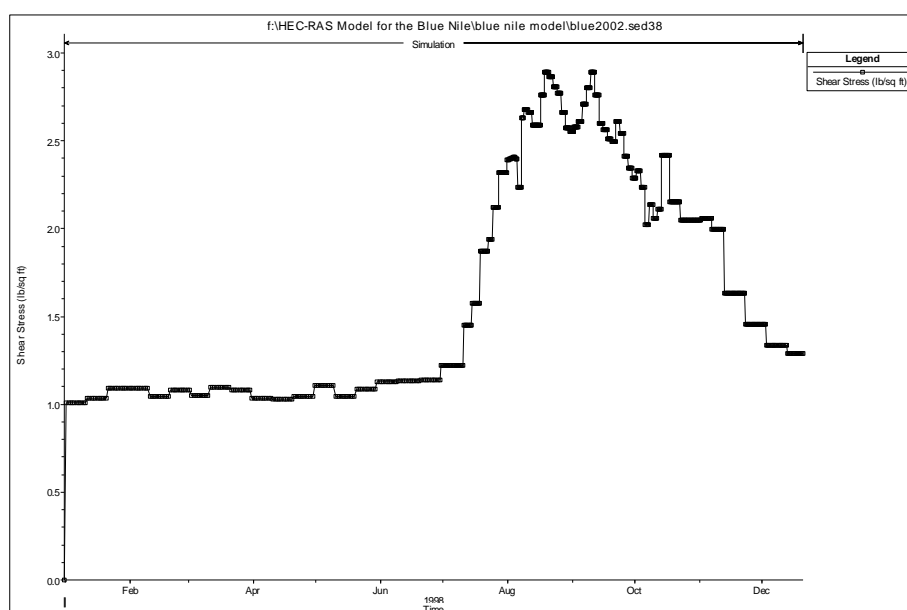
Figure 5-3d: Shear stress variation with time

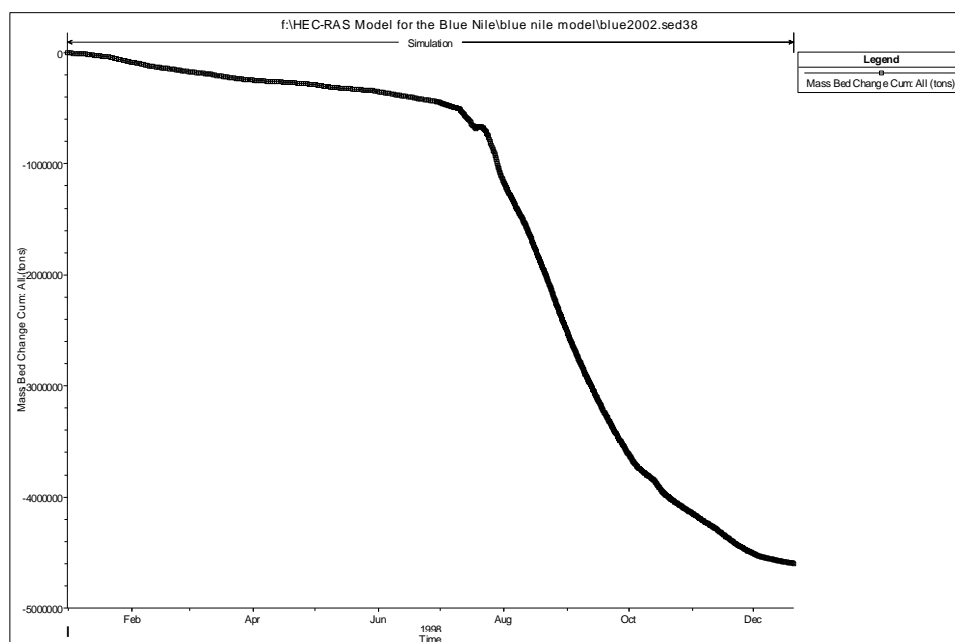
Figure 5-3e: Cumulative Mass Bed

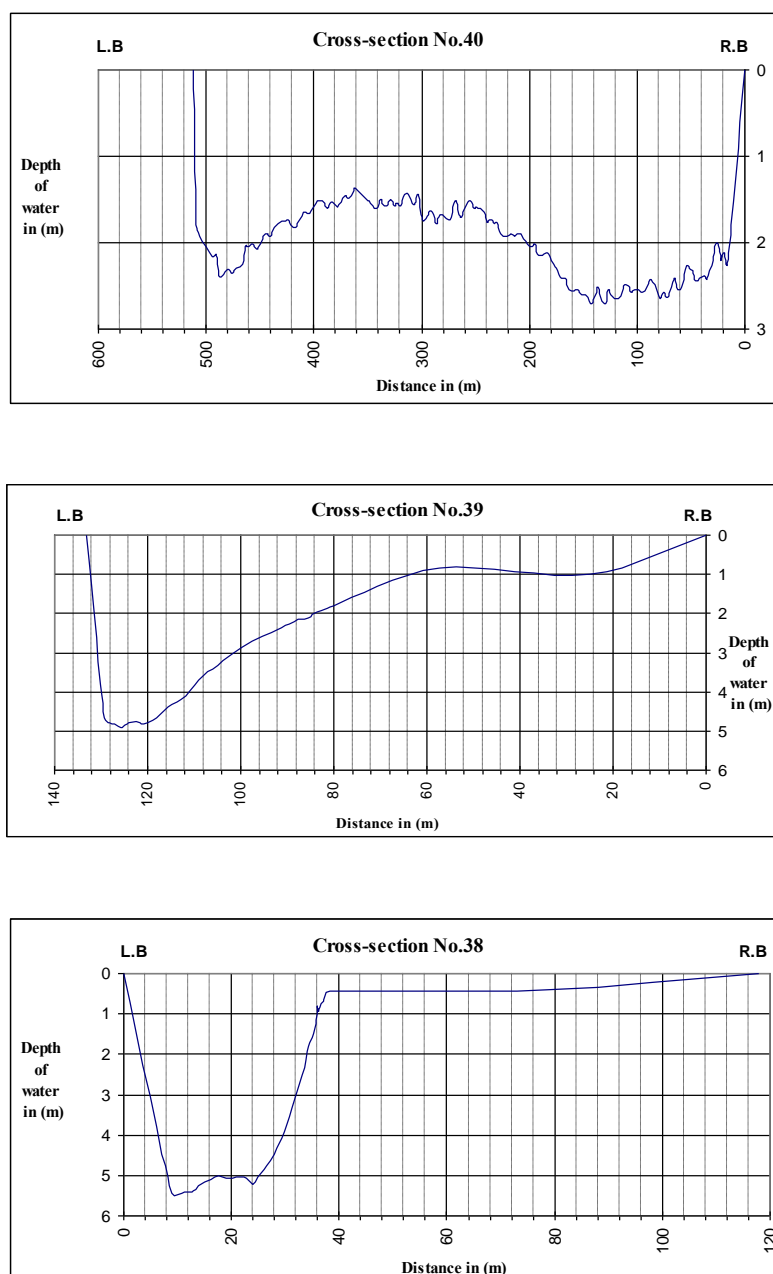
Figure 5-4: Cross sections showing erosion development near Khartoum

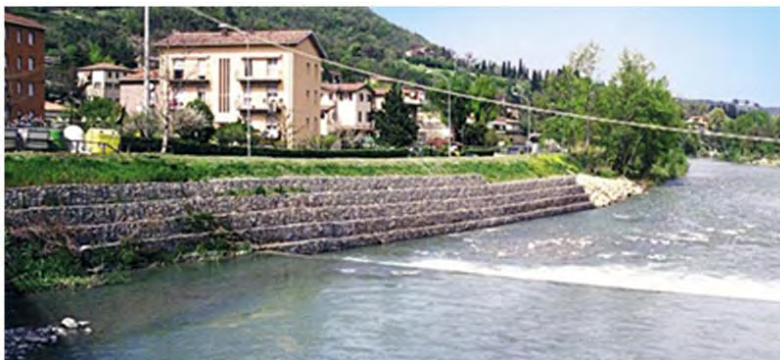
Figure 5-14: Typical guide bank gabion walls

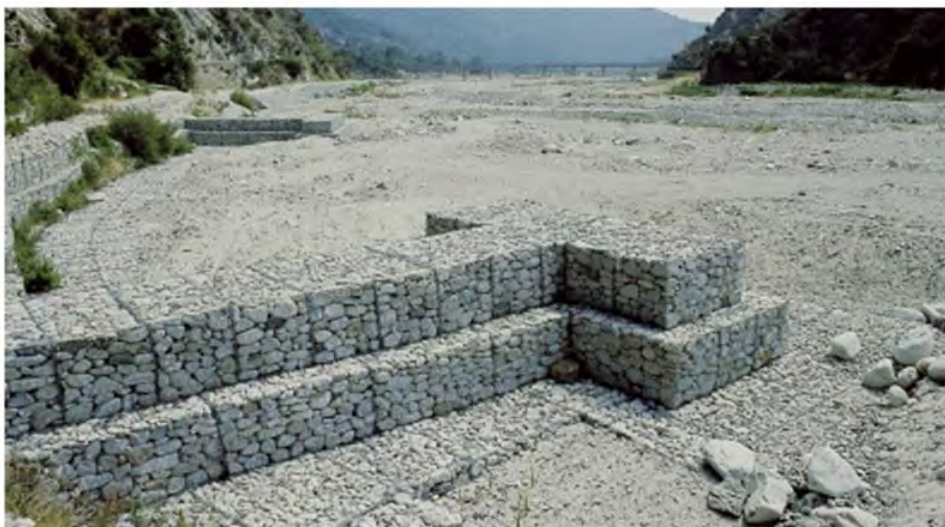
Figure 5-15: Typical gabion groynes in construction

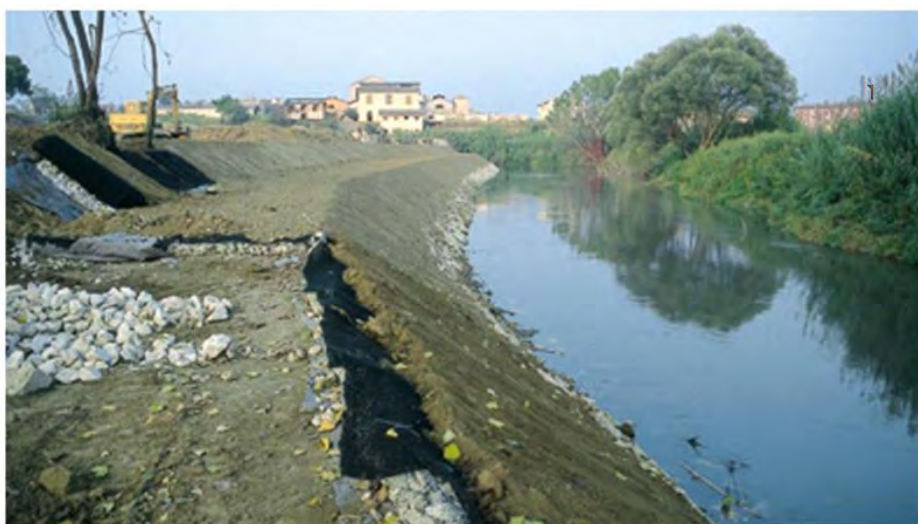
Figure 5-16: Guide bank failure

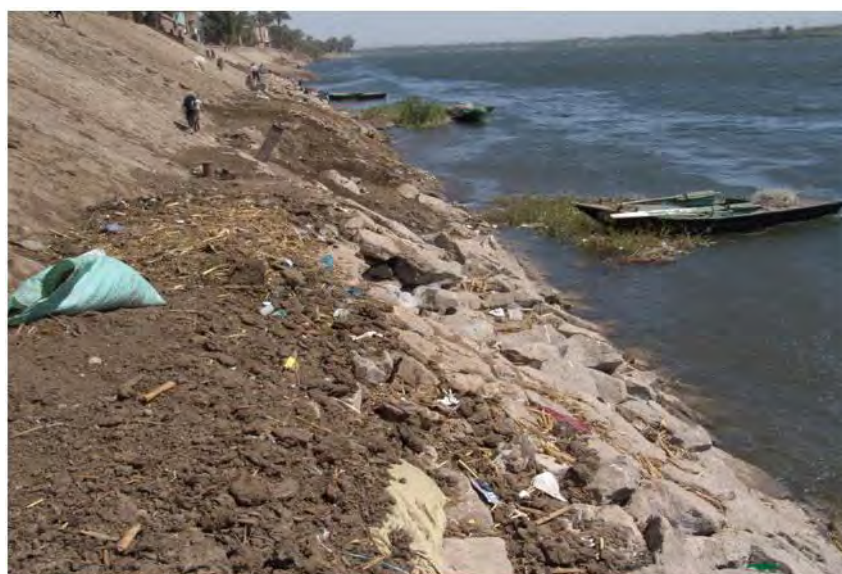
Figure 6-2: General view of bank toe protection

The geometric and topographic characteristics of Salam village consist of 4m wide road which separates the village from the western Nile River bank. The bank side slopes are 1:1 up to bank height of 3 m. There is 4m berm at bank height of 3m, followed by another berm of 1.5 m wide. This is followed by a side slope of 1:1 to 1m below the minimum water level. The bank was protected by stone pitching, which survived for a period of more than 15 years. Some holes with failure in some places appeared in the bank as shown in Figure 6.2.

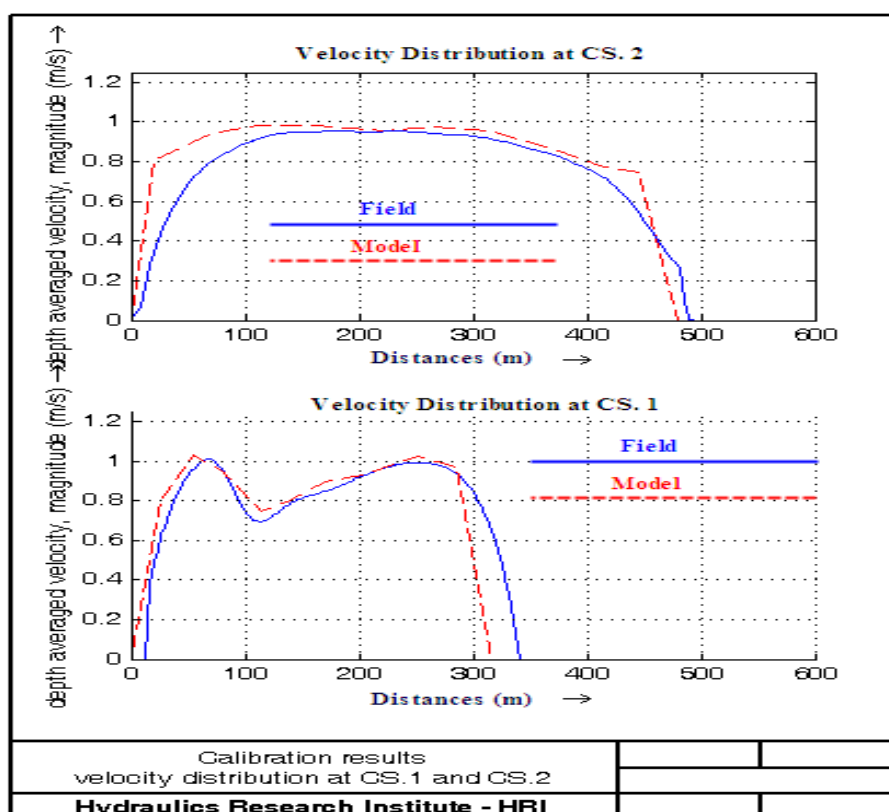
Figure 6-4: Measured and simulated velocity at Sections 1 and 2

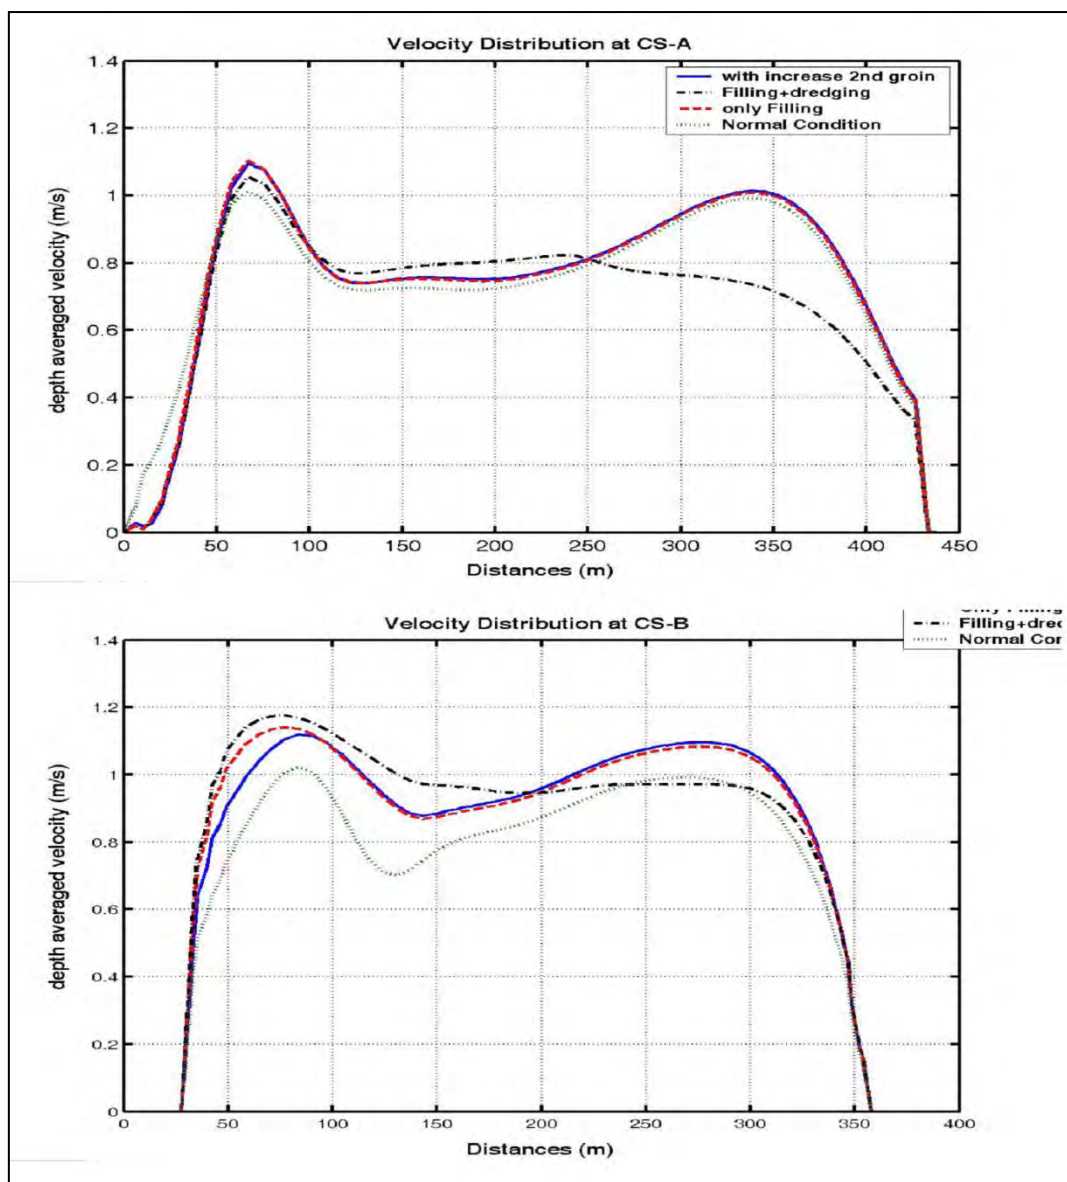
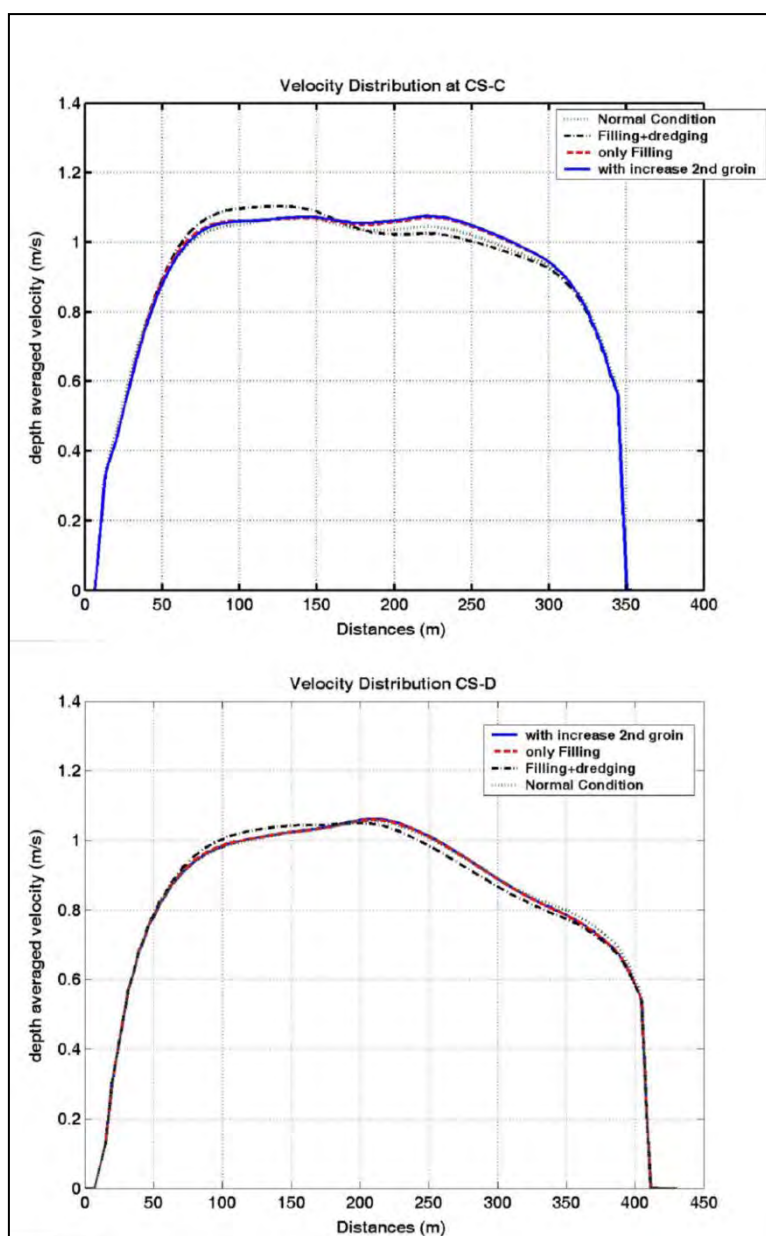
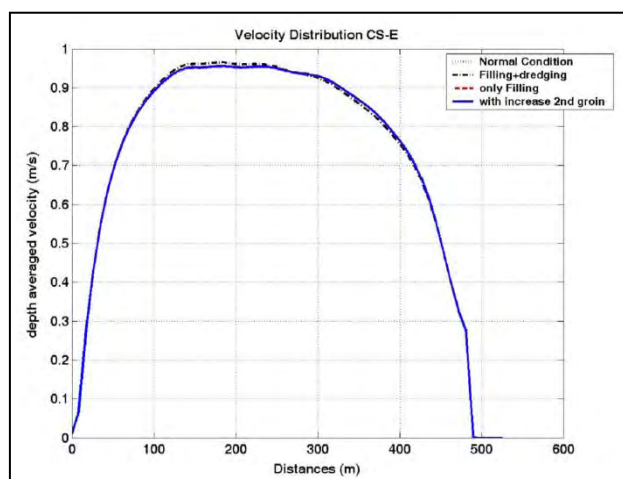
Figure 6-6a: Depth-averaged velocity for different scenarios

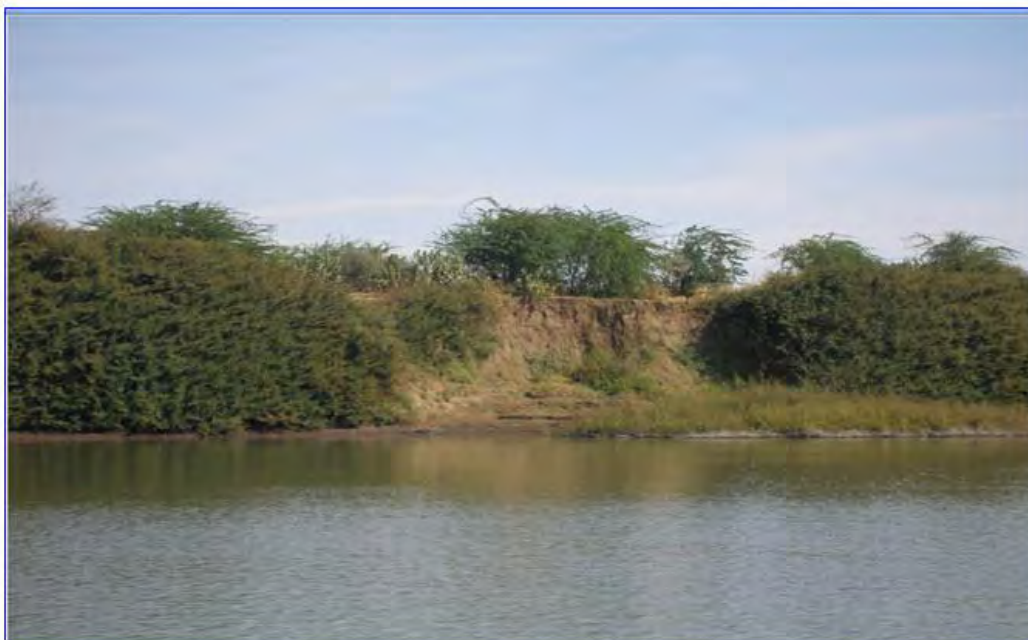
Figure 6-10: Erosion of the eastern bank upstream of the bridge site

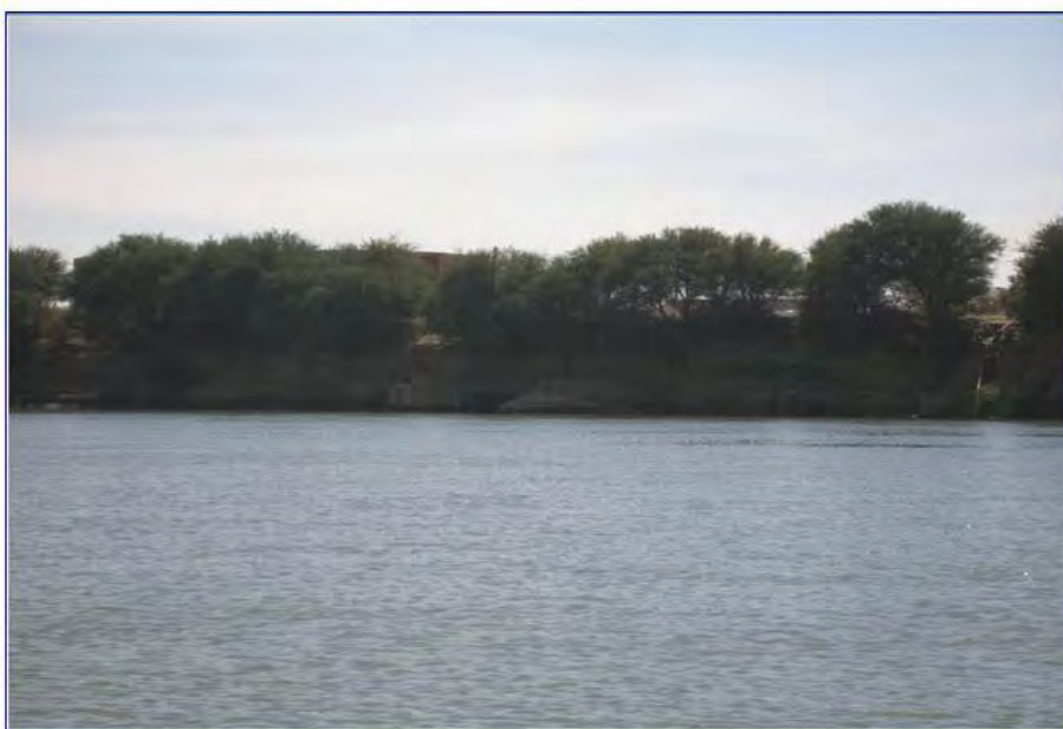
Figure 6-11: Erosion of the western bank upstream of bridge site

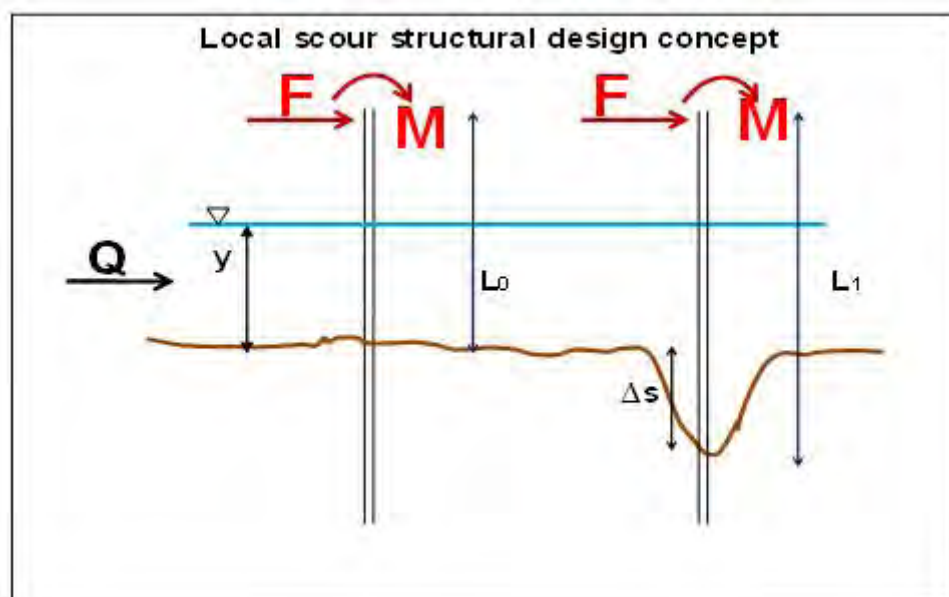
Local scour is observed to occur when the flow direction is obstructed by a body or abruptly changed. These results in high flow accelerations at the boundaries of the obstructed body and generation of horizontal and vertical strong vortices that lead to material removal and generation of scour hole around the structure. Figure 6.16 shows local scour concept.

Figure 6-16: Local scour concept
