# **NILE BASIN CAPACITY BUILDING NETWORK RIVER ENGINEERING**

**RIVER STRUCTURE RESEARCH CLUSTER  
-ETHIOPIA-**

**RESEARCH REPORT: MICRO-DAMS GROUP**

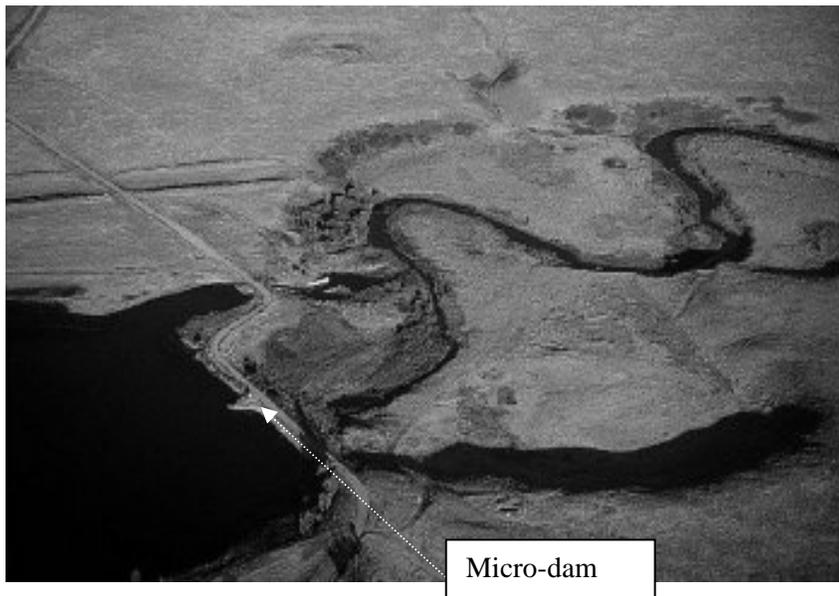
Figure 1. Small earth-fill dam – reservoir at left bottom.

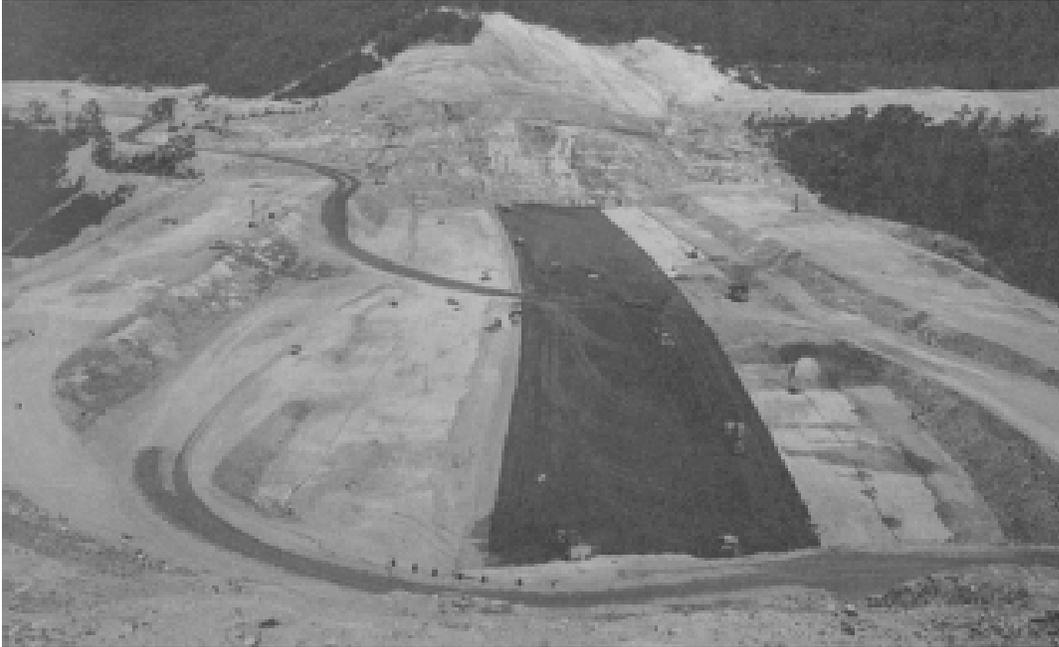
Figure 17: Foundation preparation

The thickness of the core will depend primarily on the material available, i.e. if good clay is available at low cost one would tend to be liberal with the core. The core width will often be related to the type of foundation (example Figure 17), the permissible hydraulic gradient along the contact zone.
